# Chapter 7. Shoreline Projects

## 2004 Shoreline Inventory (Blue Water Science)

## 2009-2015 DNR Shoreline Habitat Restoration Grants

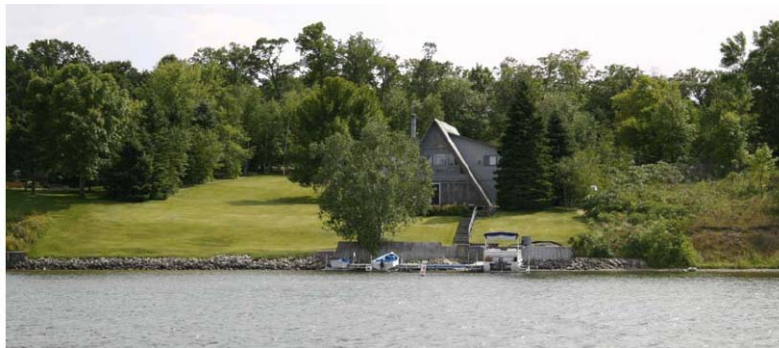
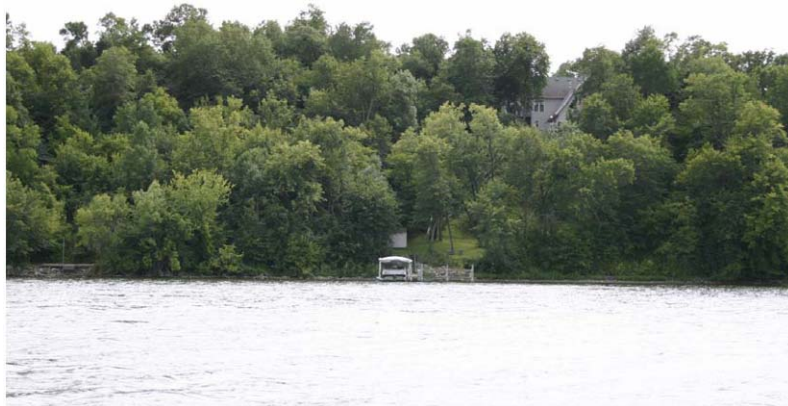
Figure 7.1 Both of the pictures are from Pelican Lake.  
 [bottom] This parcel would rate as having a shoreline with a buffer greater than 50% of the lot width and an understory with greater than 50% natural cover.  
 [top] These parcels would not qualify as having a natural shoreline buffer greater than 50% of the lot width. Also the understory in the upland area would be rated as having less than 50% natural cover.

For each photograph the shoreline and the upland condition were looked at and evaluated. The criteria for natural conditions were the presence of 50% native vegetation in the understory and at least 50% natural vegetation along the shoreline in a strip at least 15 feet deep (Figure 7.1). Shorelines and uplands at the 75% natural level were evaluated as well.

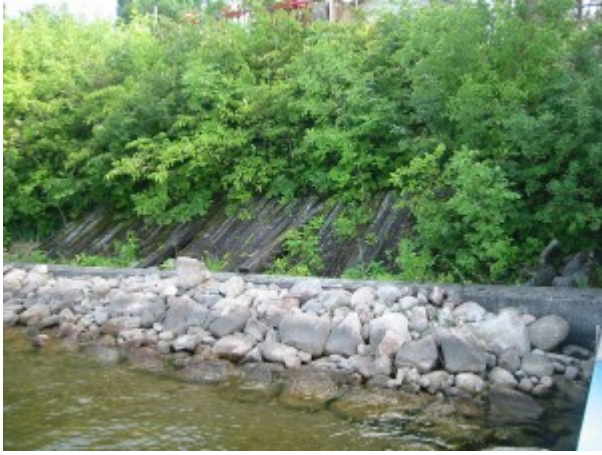
Shoreline project  
"BEFORE"

One of the participant's before and after photos are shown on the next page. On this property, railroad ties were removed and the area was filled in with soil, covered with landscape fabric, and planted with shrubs.

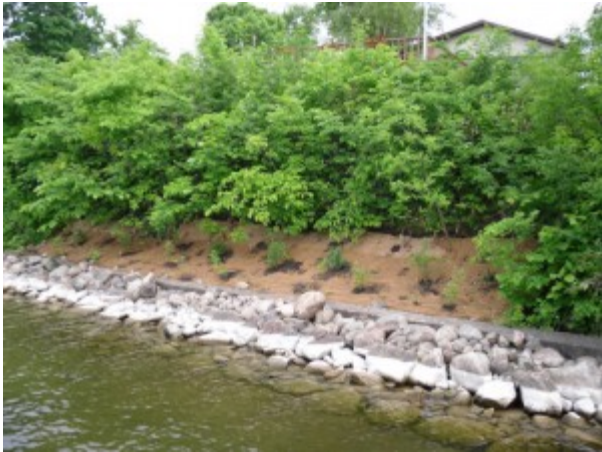
Shoreline Project  
"DURING"

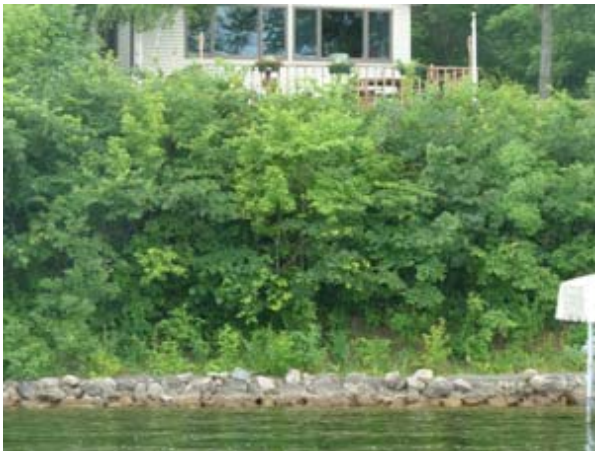
Shoreline project  
"AFTER"
